11 Alarms

11.1 General

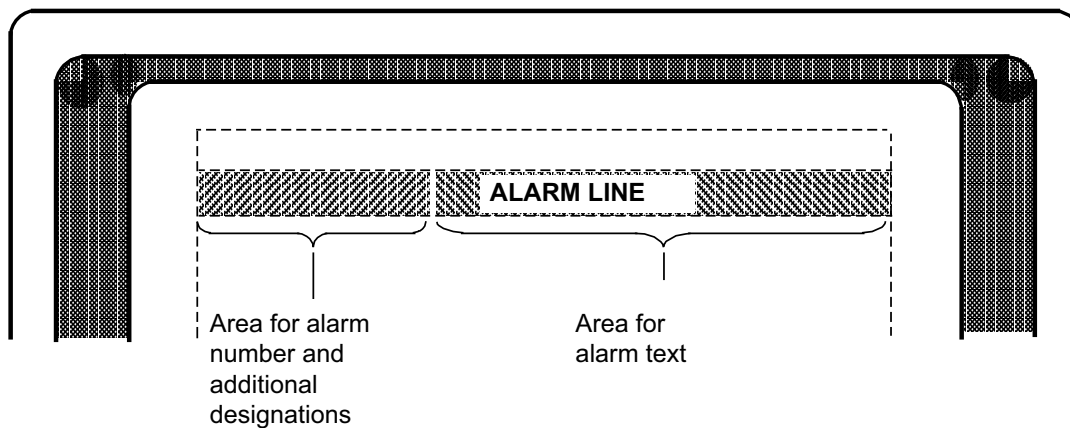
Messages from the monitor are displayed on the screen in the "Alarm line".

The "Alarm line" is the second line on the screen from the top.

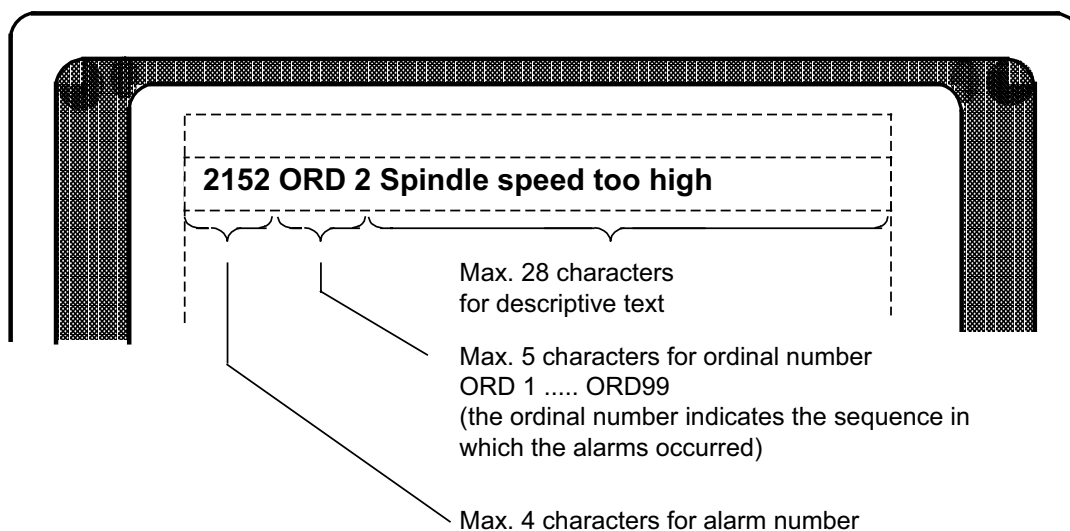
- **Example illustrating display format type A**
Applicable to alarm numbers 0 39 and 2000 2999

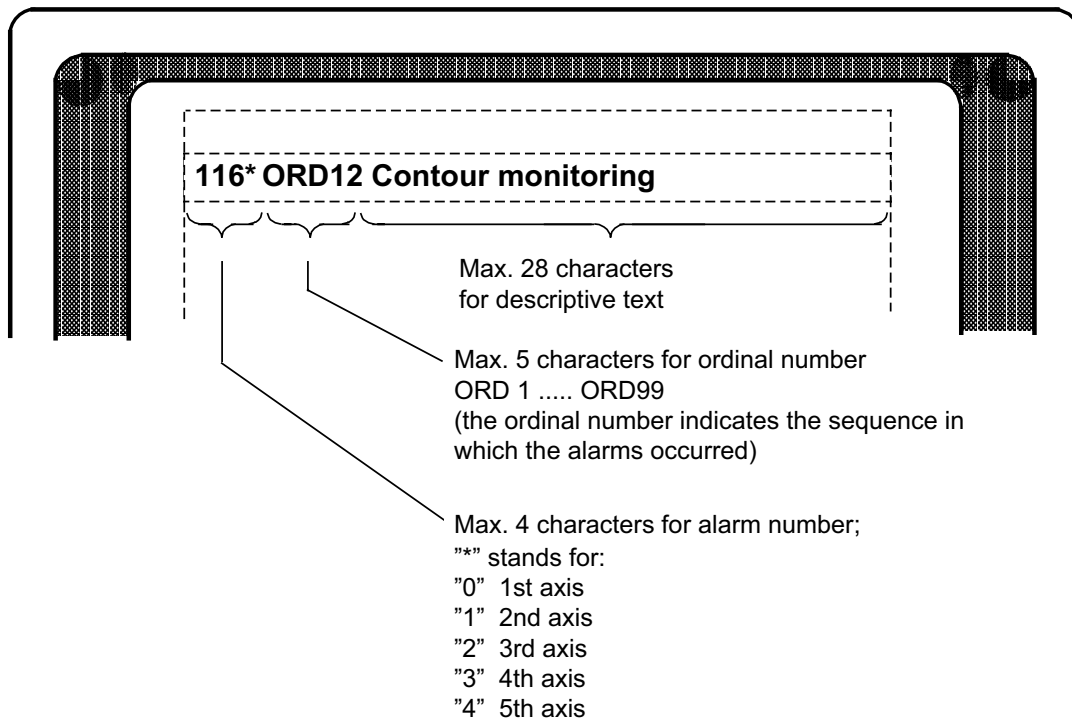
- **Example illustrating display format type B**
Applies to alarm numbers 1000 1963

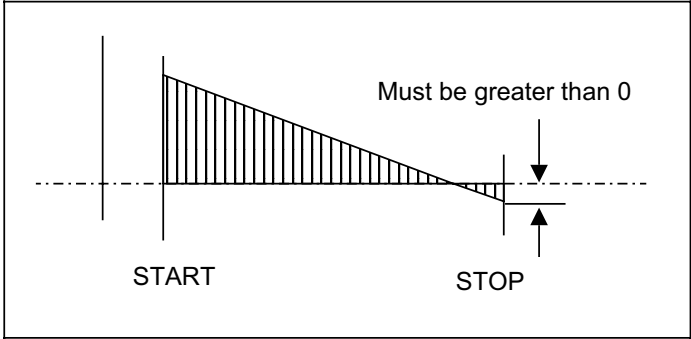
2036	G35 thread lead decr. error
Scan:	During thread cutting.
Significance:	The lead decrease in the thread is so great that a diameter of 0 or less would result at the end of the thread.

Remedy:	Program smaller lead decrease or shorter thread.
